Electric characterisation and test of double sided Silicon Strip Detectors Silicon Drift Detectors Large area Linear Silicon Drift Detectors

Rashevskaya Irina
TIFPA
03 June 2020

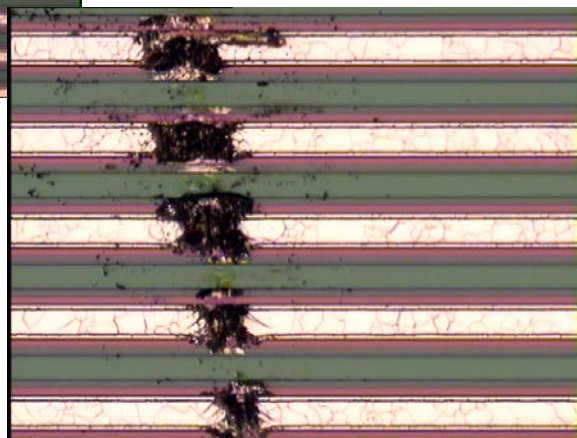
- Shorts **separated** with a tungsten probe mounted on a manipulator
- Involved AC capacitors retested after separation. OK:
 - No broken AC capacitors
 - No shorts
 - No opens

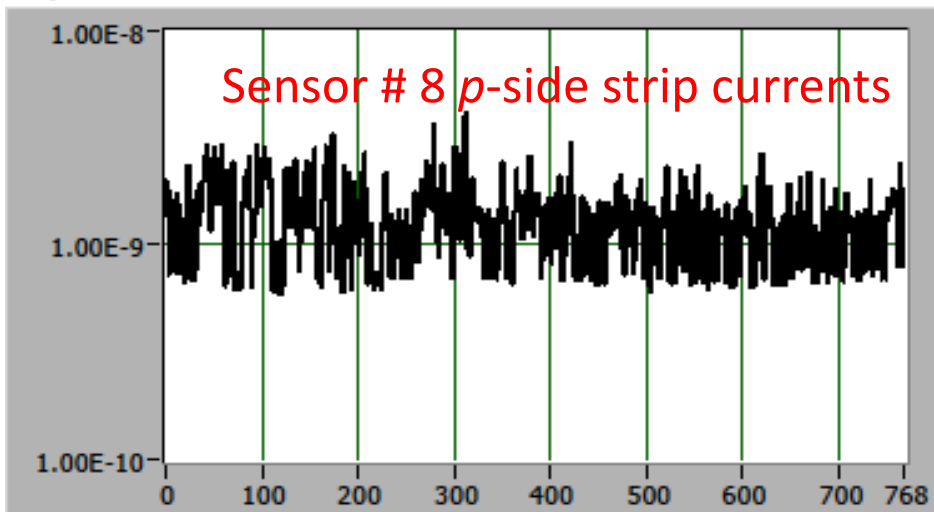
Strip current

HPK Sensor # 8

p -side DC scan

The fluctuating currents ($< 1\text{ nA}$ variations) are due to small voltage offsets between the measuring channels, interconnected by a few $\text{M}\Omega$ resistance.

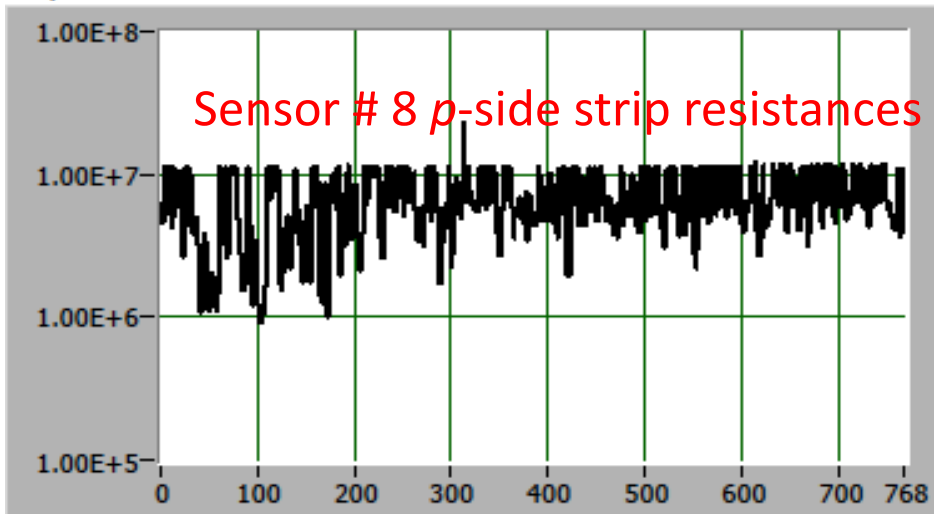
Strip resistance

Many strips have lower than normal, varying resistance while many others have quite uniform R , slightly above $10\text{ M}\Omega$ (target value). This suggests the occurrence of local surface inversion spots between the strips.

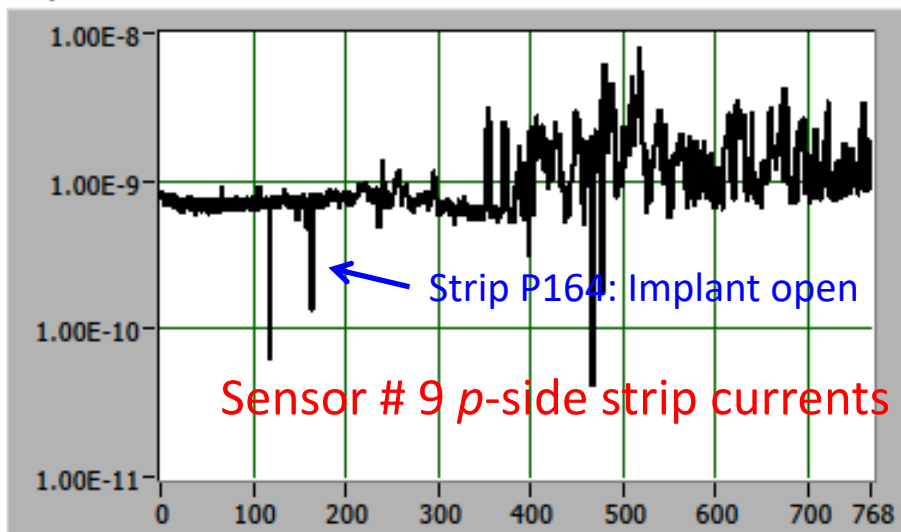
Strip current

HPK Sensor # 9 p-side DC scan

Similar problem as found on sensor # 8, but limited to the second half of the sensor.

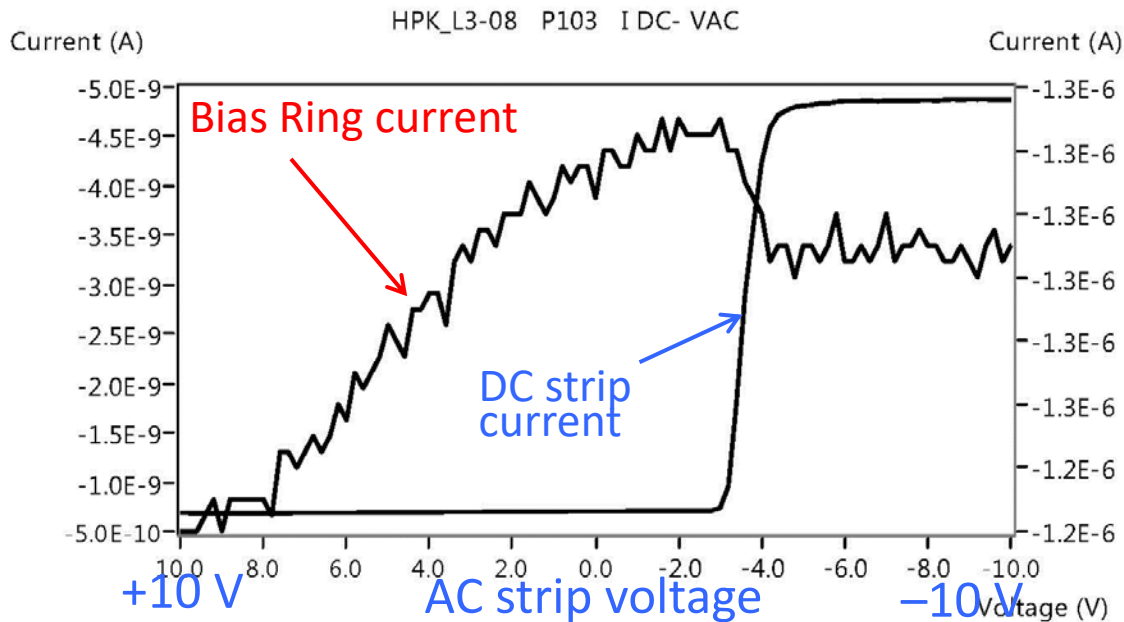
- Sensors showed signs of local surface inversion between the strips
- An attempt was made to control the interface condition by applying voltage to the insulated metal AC strips:
 - three contiguous AC strips contacted by manipulators
 - the central DC strip current has been measured as a function of the voltage applied to the three AC strips

- $V_{bias} = 150 \text{ V}$
- V_{AC} of three strips (#102, 103, 104) swept from +10 V to -10 V
- V of DC strips $\approx V_{BR} = 0$

- For $V_{AC} > -3 \text{ V}$ we measure the leakage current of a single p^+ strip ($\approx 0.7 \text{ nA}$)
- For $V_{AC} < -4 \text{ V}$ the DC strip current becomes \approx **seven times higher**, indicating that it is collecting the current of seven contiguous strips
- A corresponding drop of current is observed on the Bias Ring
- The transition is rather sharp and reversible, with no appreciable hysteresis

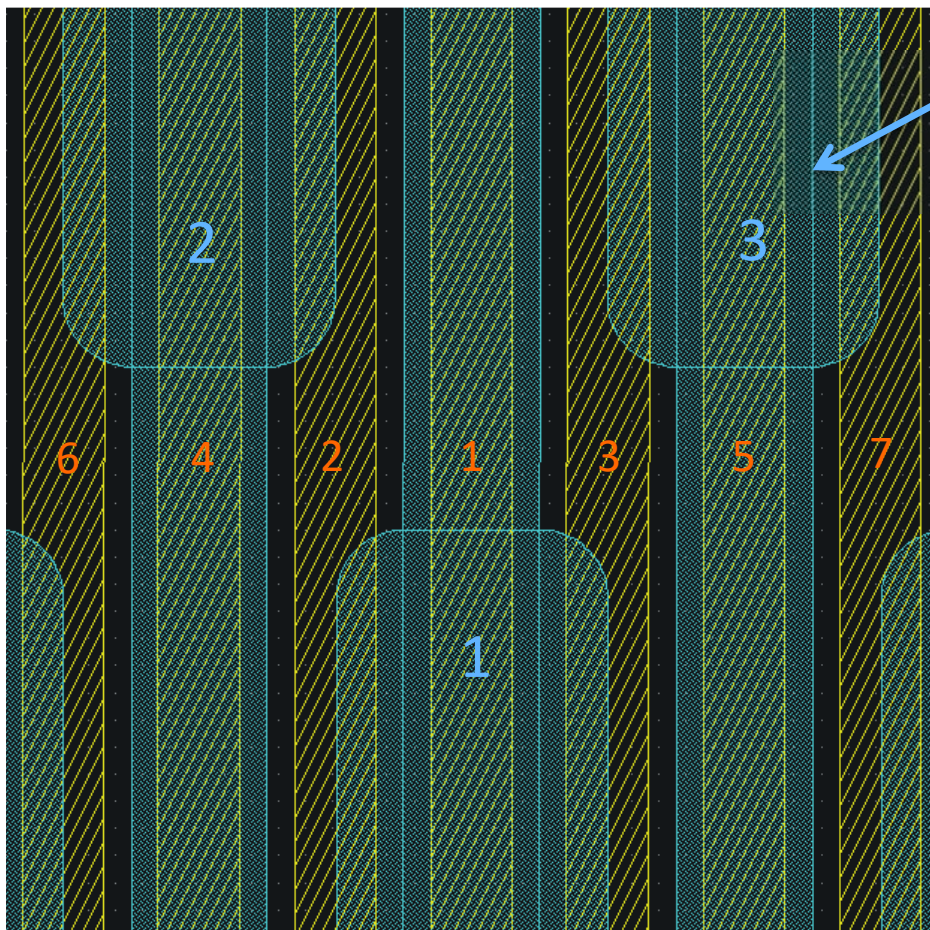
Parasitic MOSFET on p-side

Note: The layout detail shown actually belongs to a wedge (Micron) sensor, but the situation is very similar for rectangular (HPK) sensors.

- The **AC pad** overlaps the two adjacent implanted strips, acting as the metal gate of a parasitic P-MOSFET.
- If a negative voltage $< V_{thr}$ is applied, say, to **three** contiguous **AC strips**, then **seven implanted strips** (3 readout and 4 non-readout) **get shorted together**.
- This effect is immediately reversible by changing the voltage applied to the AC pads.
- However, the parasitic MOSFET may also be switched on by *ions slowly drifting* on the outer sensor surface or in the dielectric layers. This may lead to *inversion of portions of the interface not directly controlled by the metal gate*, an effect that is subject to large and poorly controllable hysteresis.

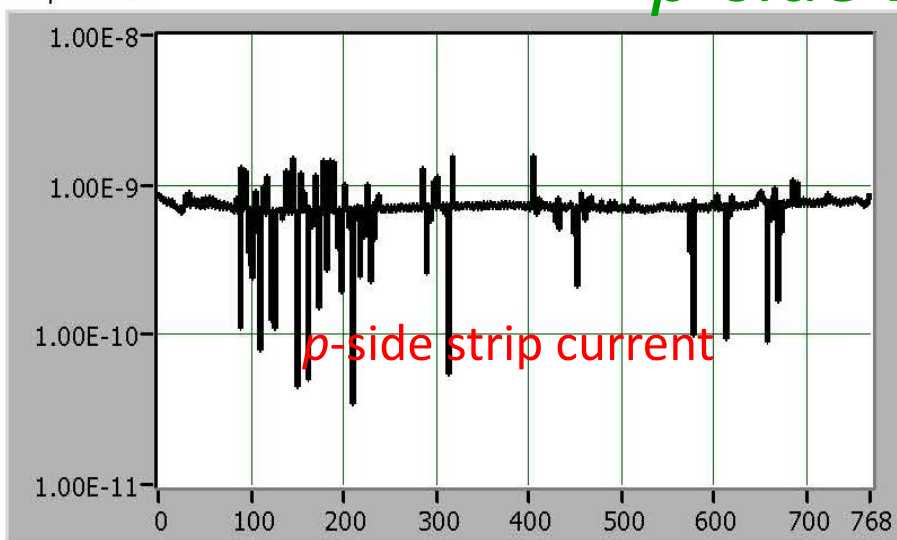
Strip current

HPK Sensor # 8

p-side DC scan # 2

By biasing all AC strips at +10 V for a short time (10 s) strip insulation has been recovered

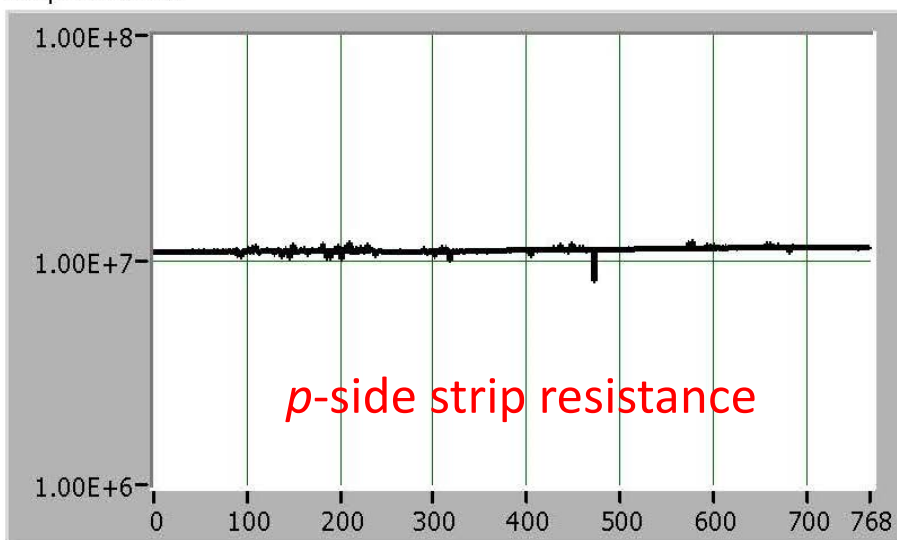
Strip resistance

After AC scan with

$$V_{AC} = +10 V$$

0 strips have $R < 10 M\Omega$

(the one shown in the plot had a probe contact problem)
